May 2014

## **C6 Power Top Trunk Partition Retainer Failure**

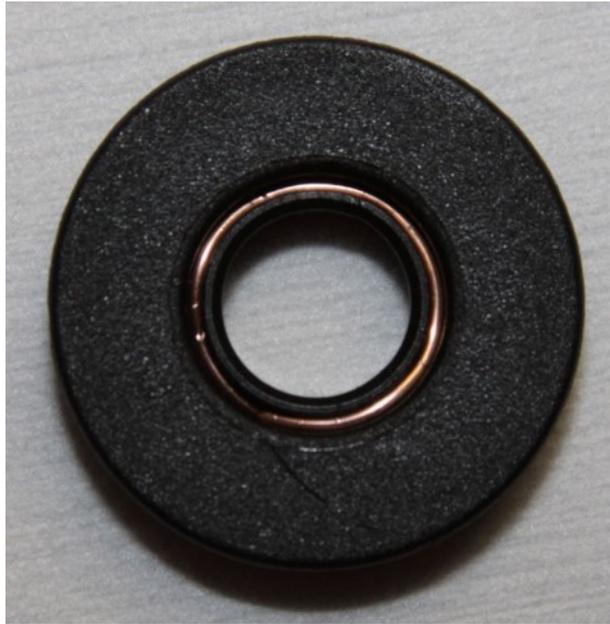
You can also somewhat repair the retainer. I say somewhat as it doesn't quite fit as snugly as it did originally. The failure of the retainer is caused by the plastic center ring cracking, and it will start to separate when you push it on the male clip and it won't stay on. If you have some 16-gauge solid wire handy, strip off ~2in of it and wrap it in the groove around the retainer.

This helps keep the center plastic ring from spreading, and thus helps the retainer stay put. It won't be as tight as a non-cracked retainer, but it is much better than a cracked one.
